**The TRANSFORMATION STORY of  
a MANSION IN THE WALLED CITY  
of NICOSIA**

**Author:**  
Aliye Menteş

### DAMAGE ASSESSMENT AND RESTORATION PROCESS OF THE MANSION

### REPAIR AND IMPLEMENTATION WORKS ON IRONWORK AND WOODWORK IN THE MANSION

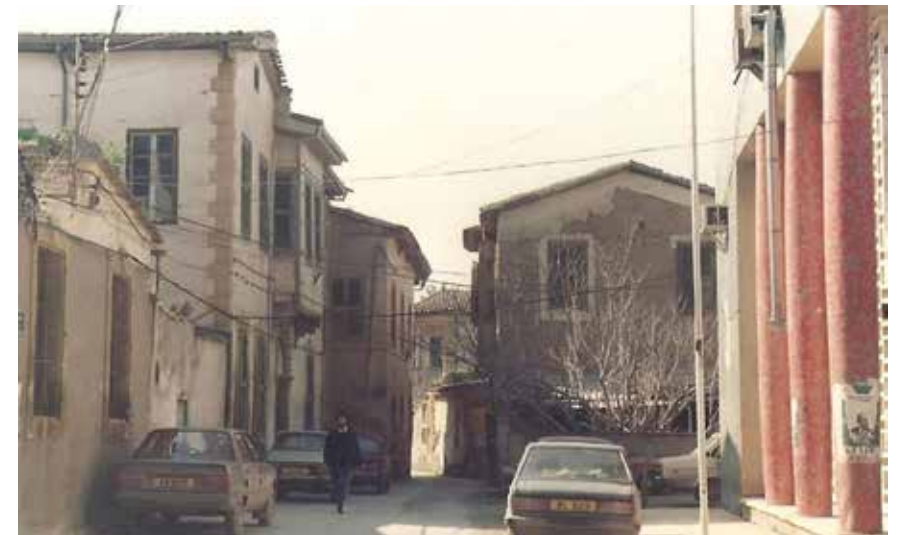
Figure 10. Appearance of Nuri Efendi Street No. 3 in the 1980s; the bay-windowed house where the Shakespeare School relocated in 1950 (Tuncer Bağışkan, 2018)

In addition to this information, the building was also known at one time as the Shakespeare School. In his article “A Philosopher and a Shakespeare School Passed Through Cyprus,” archaeologist Tuncer Bağışkan describes the private English-language Shakespeare School established in the 1920s by philosopher Necmi Sagıp Bodamyalızade. It is noted that the school was initially located at No. 15 İdadi Street and later moved in 1950 to the bay-windowed house at No. 3 Nuri Efendi Street (Figure 10). It is also stated that this house was rented

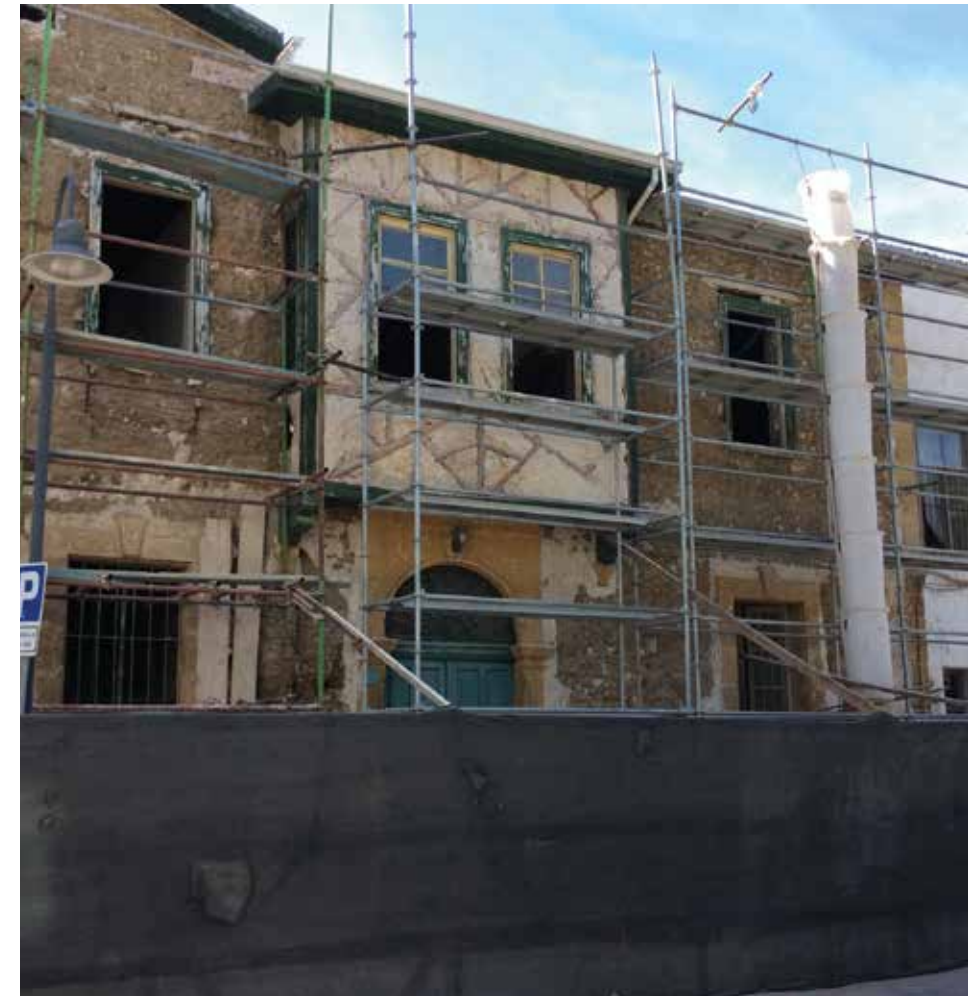
According to damage assessment analyses conducted by structural engineers and restoration specialists, partial settlement occurred in the foundation due to water infiltration from the roof at the western corner of the front façade, causing serious structural damage. Following a three-month monitoring period (Appendices, Appendix 1 and 2), it was observed that cracks in the walls had expanded, affecting both floors and posing a risk of partial collapse. Cracks were also identified on the north and west façades, and reinforcement using timber stitching was deemed appropriate. As Taneri (2015) notes:

“As a result of damage on the wall to the left of the entrance door, an outward bulging occurred. To prevent collapse, the wall was urgently stabilized by anchoring it to adjacent sound walls using steel ties, which were gradually tightened until the issue was resolved. During this process, window jambs were also gradually repositioned to their original alignment.”

*Figure 11a: The pre-restoration condition of the front façade (Menteş, 2015)*

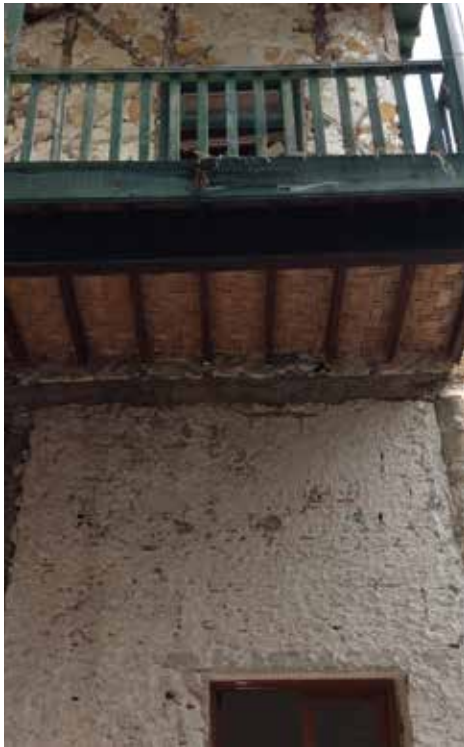
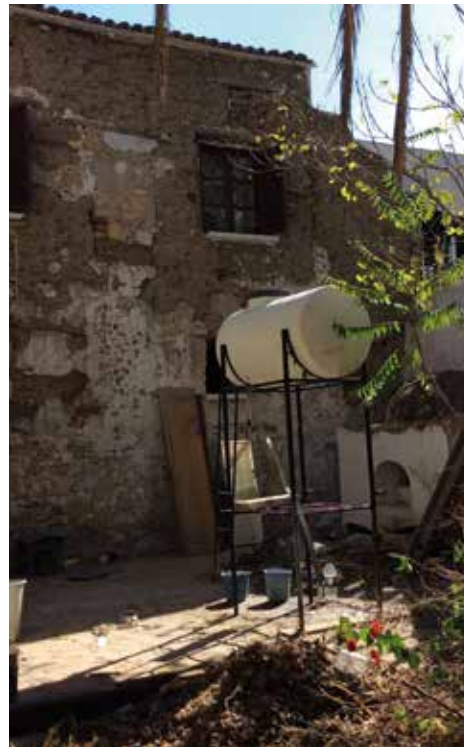
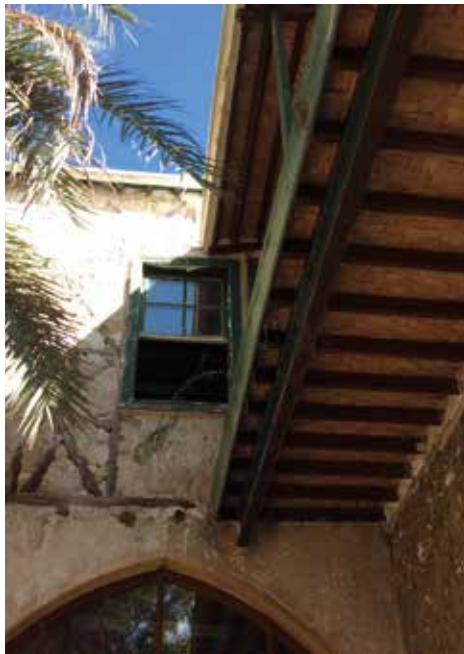
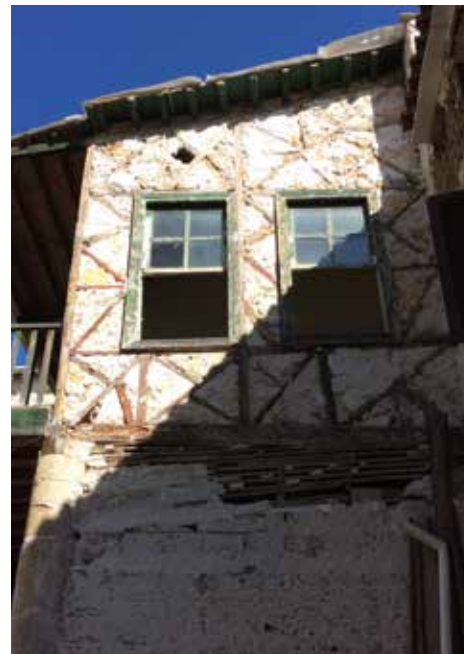
off. On the façade facing the courtyard, it was observed that a reinforced concrete column beneath the balcony remained as a trace of previous interventions. In the courtyard, the dome of the bathhouse showed heavy soiling caused by biological and botanical growth (Figure 11).

Figure 11b/c/d/e: The pre-restoration condition of the façades (Menteş, 2015)

used in the structure. Wall materials were cleaned, strengthened, and conserved according to their specific characteristics and condition assessments. All plaster was removed where necessary, and appropriate material repairs and structural reinforcements were carried out. Stone masonry walls were left exposed to allow the material and its texture to “breathe.” After removing cement-based mortars used in

earlier inappropriate repairs, a compatible hydraulic lime-based mortar was applied in accordance with the historic fabric and material properties. In adobe (kerpiç) walls, necessary material repairs were completed, wire mesh reinforcement was applied, and the surfaces were re-plastered with gypsum.

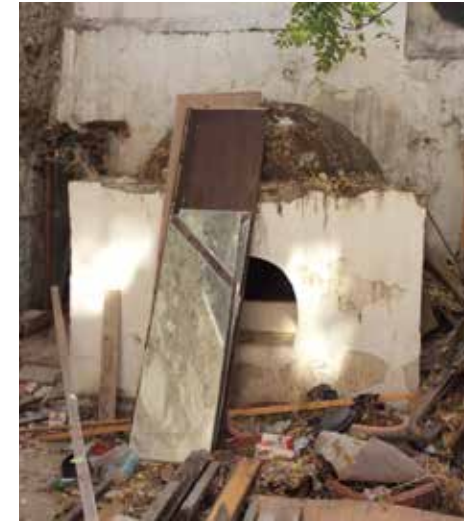
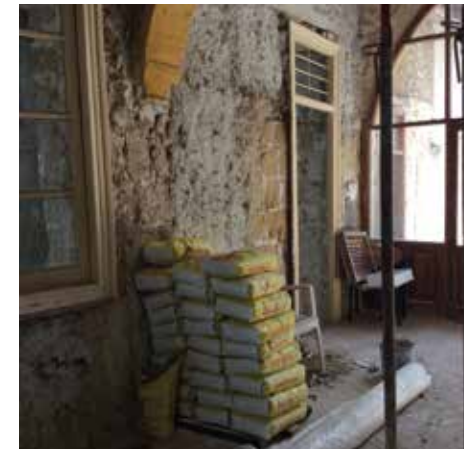
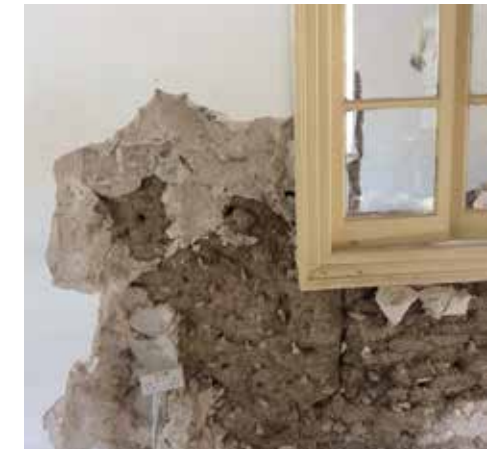
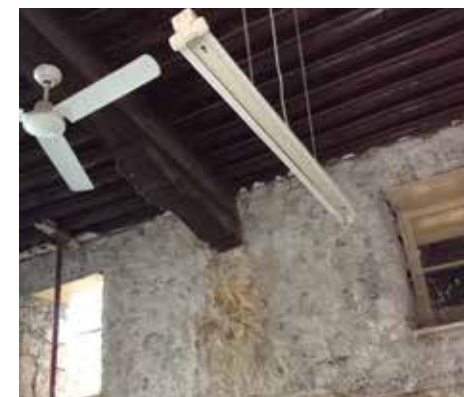
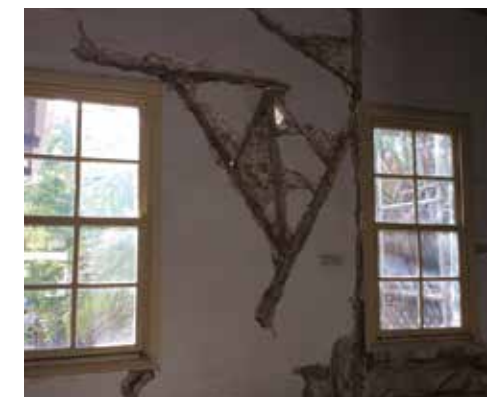
Figure 12a/b/c/d/e/f: The pre-restoration condition of the hamam (Turkish bath) and the interior elements of the mansion (Menteş, 2015)

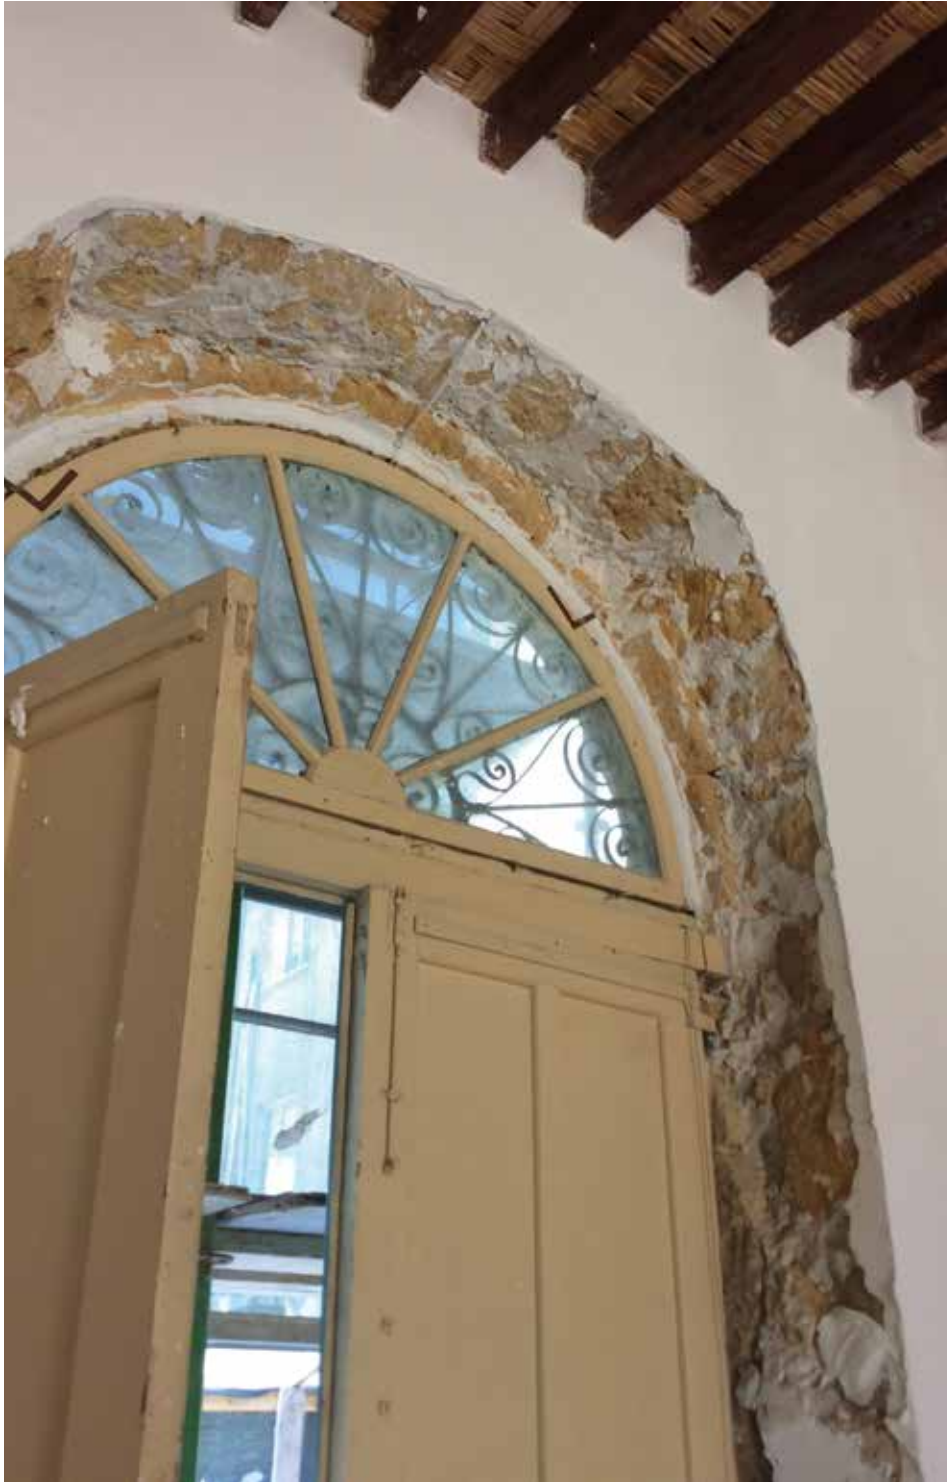
Figure 12g: The pre-restoration condition of the front door  
(Menteş, 2015)

The original entrance door and arched courtyard door were cleaned, repaired, and repainted before being reinstalled. Some interior room doors had broken panels, which were reconstructed in accordance with the originals.

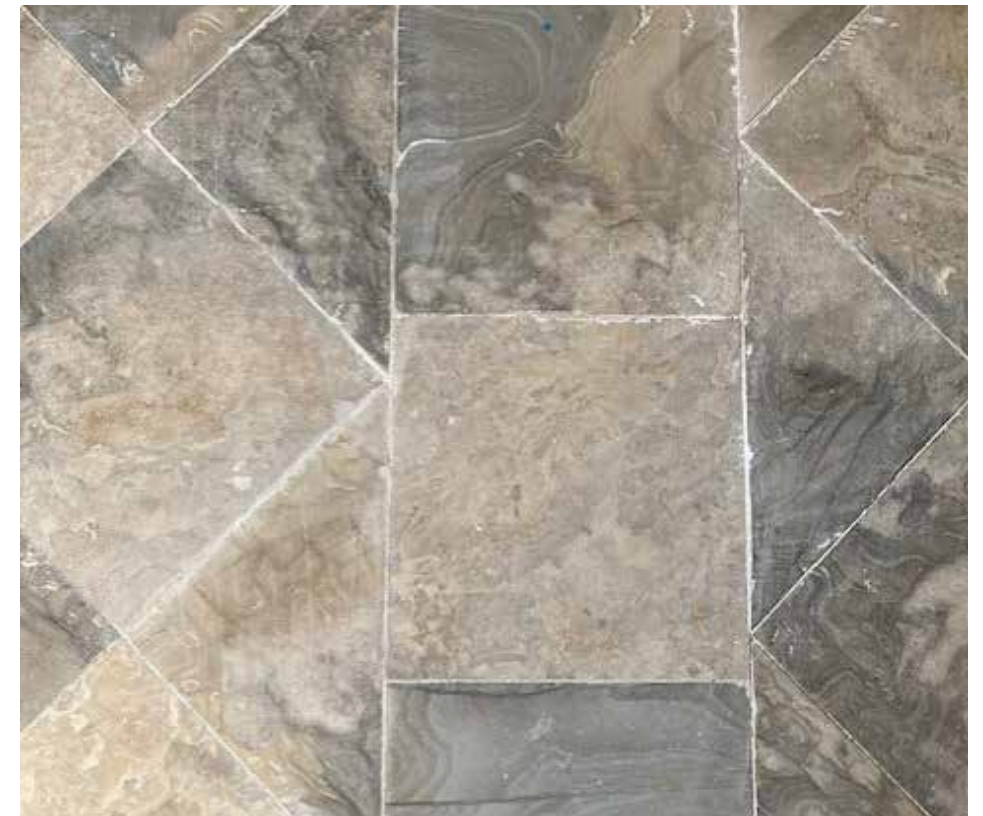
The ground floor, paved mainly with Cyprus marble, was largely in good condition; however, settlement was identified in some areas. In the affected zones, the marble

Figure 13: Example of original Cyprus marble used in the building  
(Menteş, 2015)

slabs were carefully removed, the subfloor level was corrected, and the stones were reinstalled.

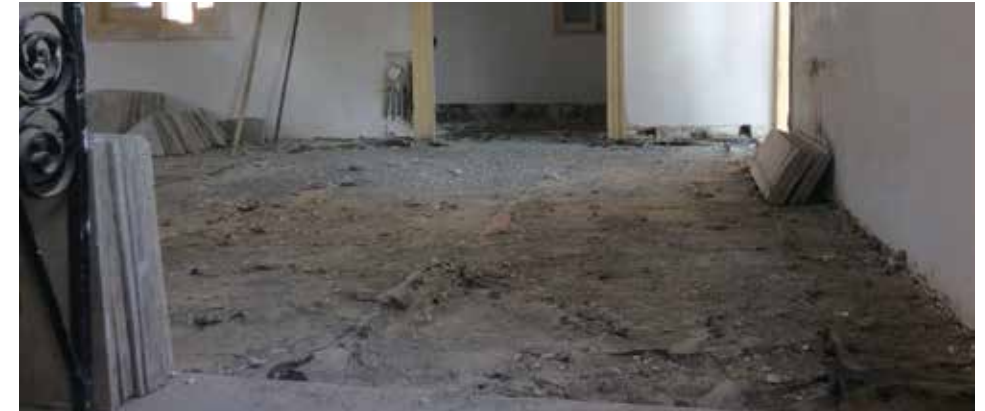
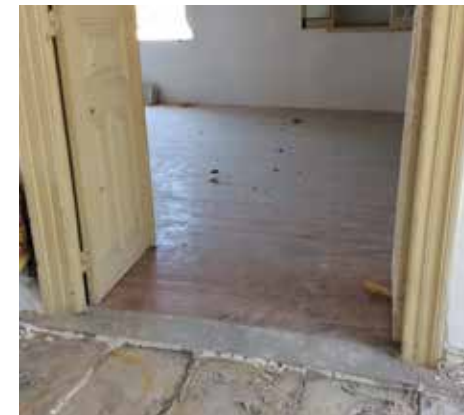
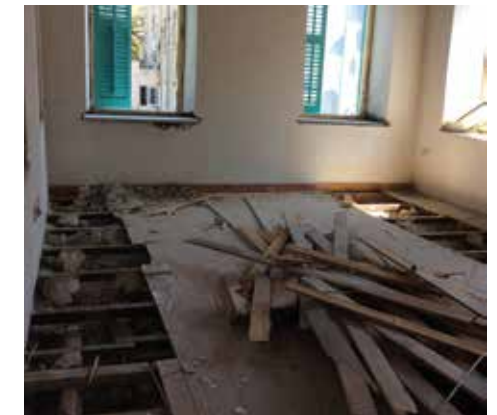
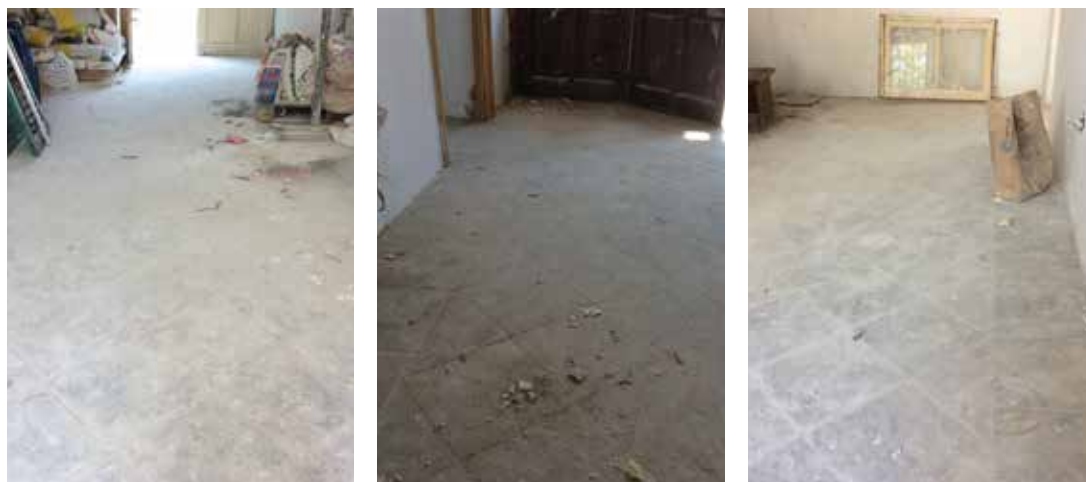
**Figure 15a/b/c: Condition of Cyprus marble floors on the ground floor and preparatory works before restoration: Entrance hall (Menteş, 2016)**

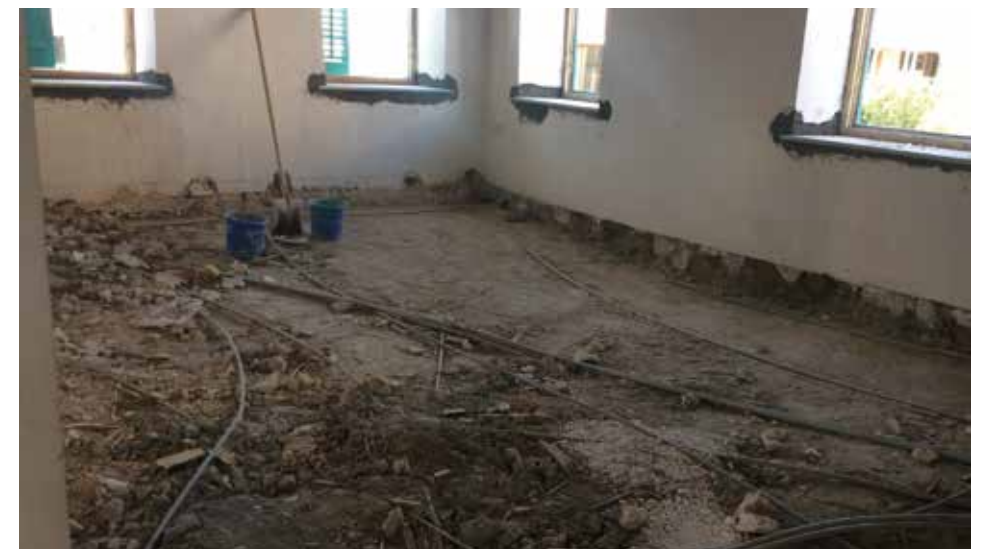
On the upper floor, the marble flooring in the entrance hall was generally in poor and broken condition. Therefore, the existing

**Figure 16a/b/c/d: Removal of damaged Cyprus marble flooring in the first-floor entrance hall and deteriorated non-original timber elements in Room 5 (Menteş, 2016)**

marble was removed, the electrical installations were renewed, and new marble flooring compatible with the original material was laid. Only one of the rooms on the upper floor had a timber floor. This non-original wooden flooring was found to be decayed and was removed.

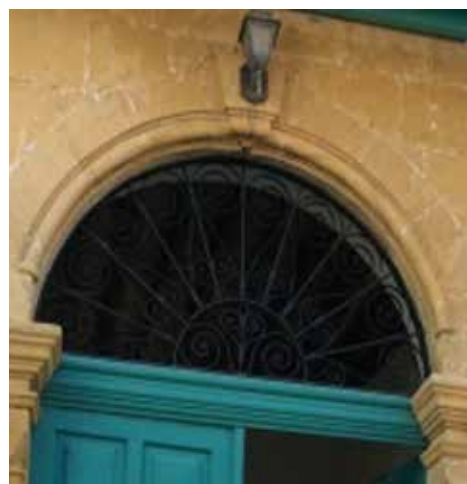
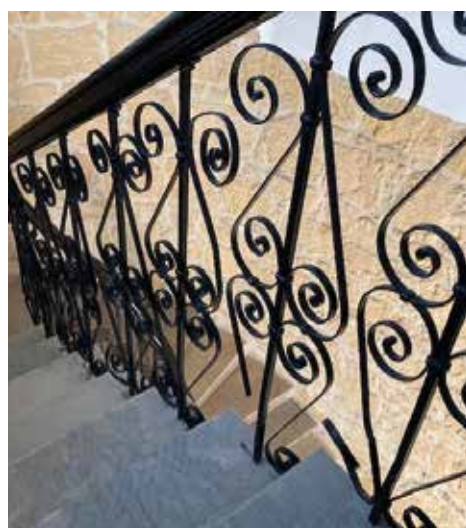
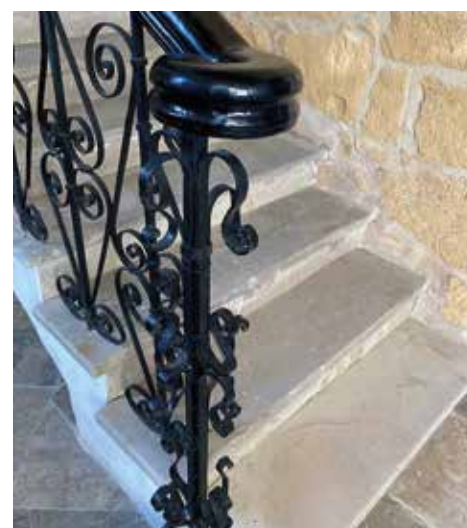
Figure 17a/b/c Staircase iron railings and decorative ironwork of the entrance door (Menteş, 2017)

**Ironwork Repairs and Interventions**  
All iron elements were cleaned, repaired where necessary, and painted black after conservation treatments. These include the original ironwork of the staircase

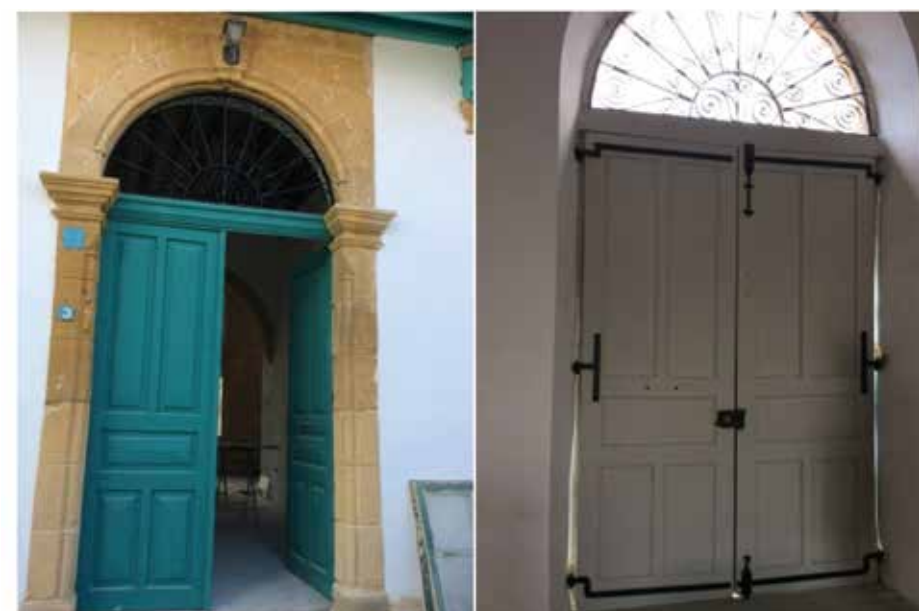
Figure 18a/b: Exterior and interior views of the entrance door before and after restoration (Menteş, 2017)

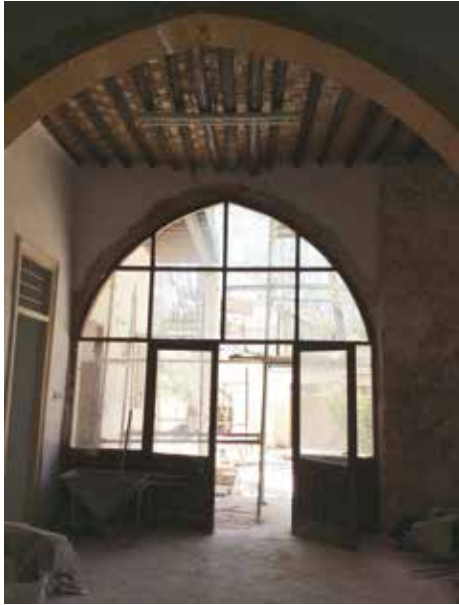
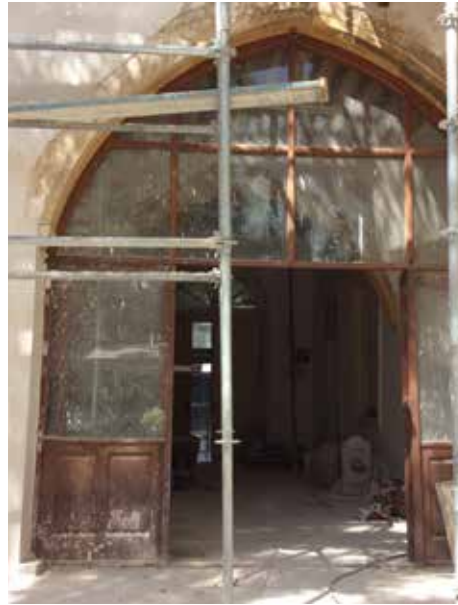
*Figure 19a/b: Exterior and interior views of the arched courtyard door before and after restoration (Menteş, 2015)*

Woodwork interventions include the main entrance door (Figure 18a/b), the arched courtyard door (Figures 19a/b, 20a/b), interior room doors, window frames and shutters (Figure 21), interior niches (Figure 22), staircase and balcony railings, ceiling timbers and rafters (Figure 23a/b), and roof eaves.

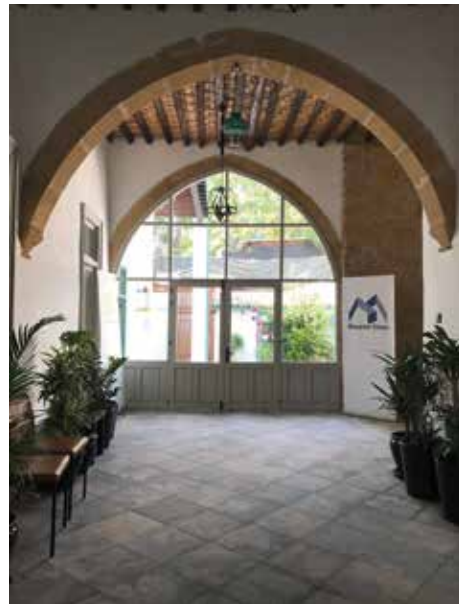
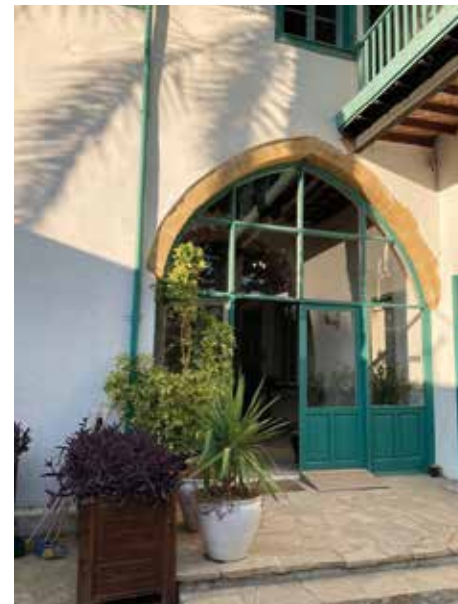
*Figure 20a/b: Exterior and interior views of the arched courtyard door after restoration (Menteş, 2015)*

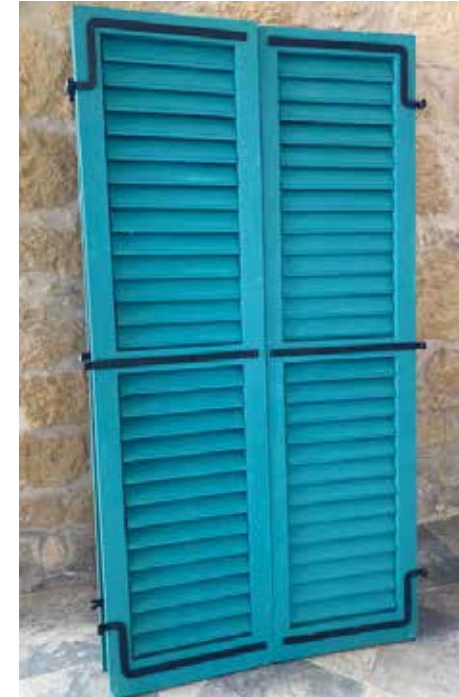
*Figure 21: Shutters after restoration, before installation (Menteş, 2017)*

of the shutters, which required a difficult and meticulous process of repair and restoration. Broken and missing parts were completed using the same material—pine wood—reconstructed in accordance with the original design.

The paint layers on the shutters were carefully burnt off in order to inspect the underlying timber and determine whether decay was present. Where rot was detected, those sections were replaced. In the window frames, decay caused by wood-boring insects was cleaned and treated; depending on their condition, the frames were either patched or entirely renewed.

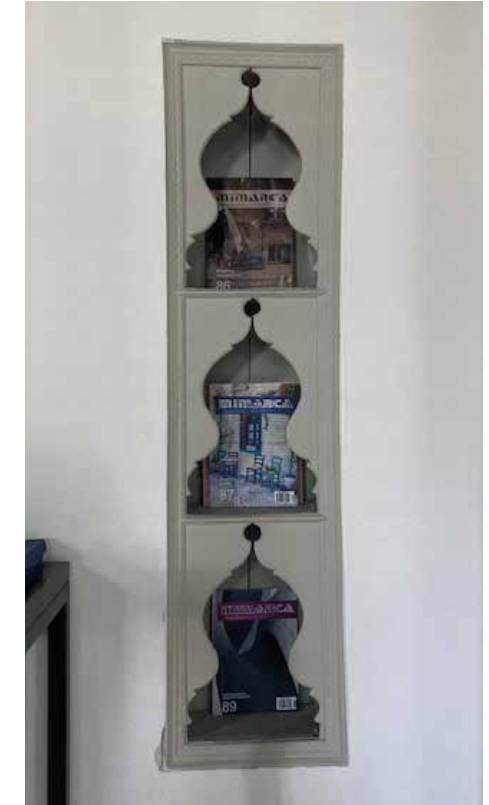
*Figure 22: Wooden niche in the upper-floor room after restoration (Menteş, 2017)*

The bay window timber elements, roof eaves, all window frames and shutters were conserved through careful maintenance. Wooden niches, ceiling beams and rafters, staircase and balcony railings were repaired and preserved.

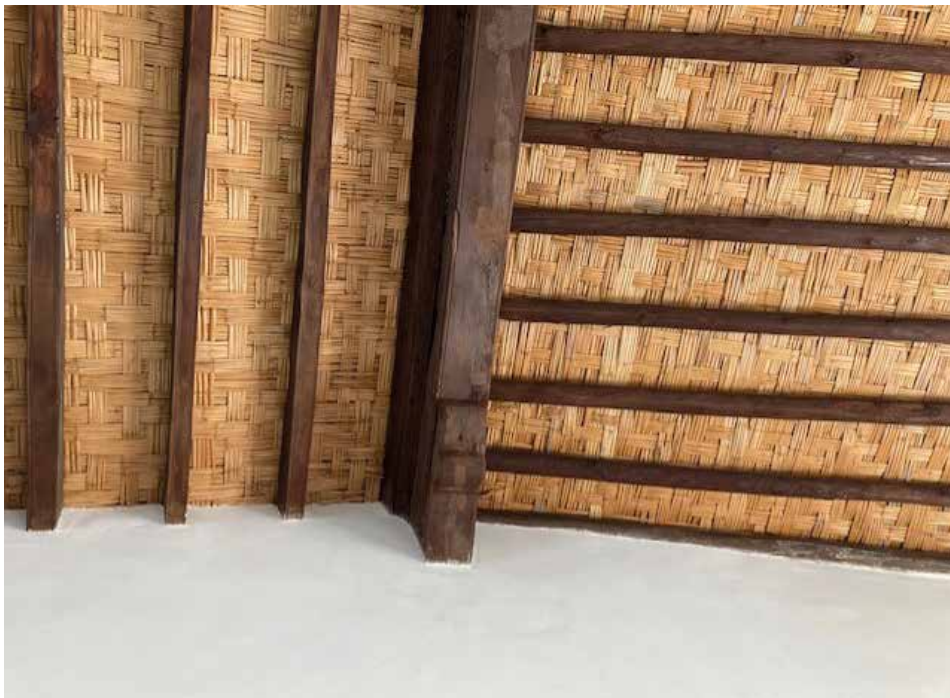
*Figure 23a/b: Condition of timber ceiling, rafters, and woven cane after conservation (Menteş, 2017)*

The wooden rafters in the ceiling were found to be in good condition. After cleaning, chemical treatment, and repainting, no further structural intervention was required. The reed matting (hasır) elements in the ceiling were also preserved through cleaning and maintenance only.

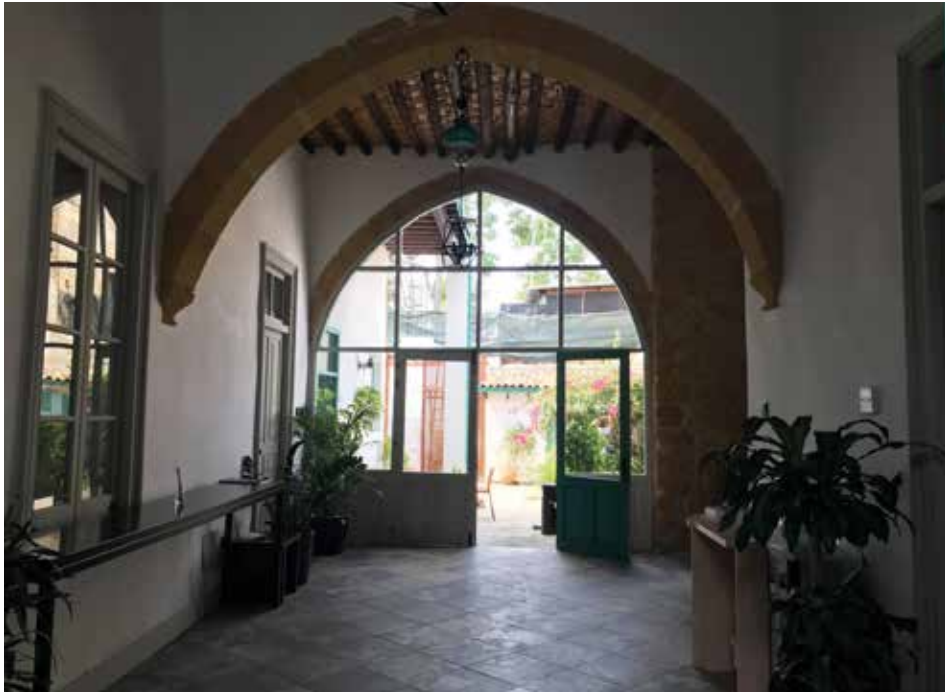
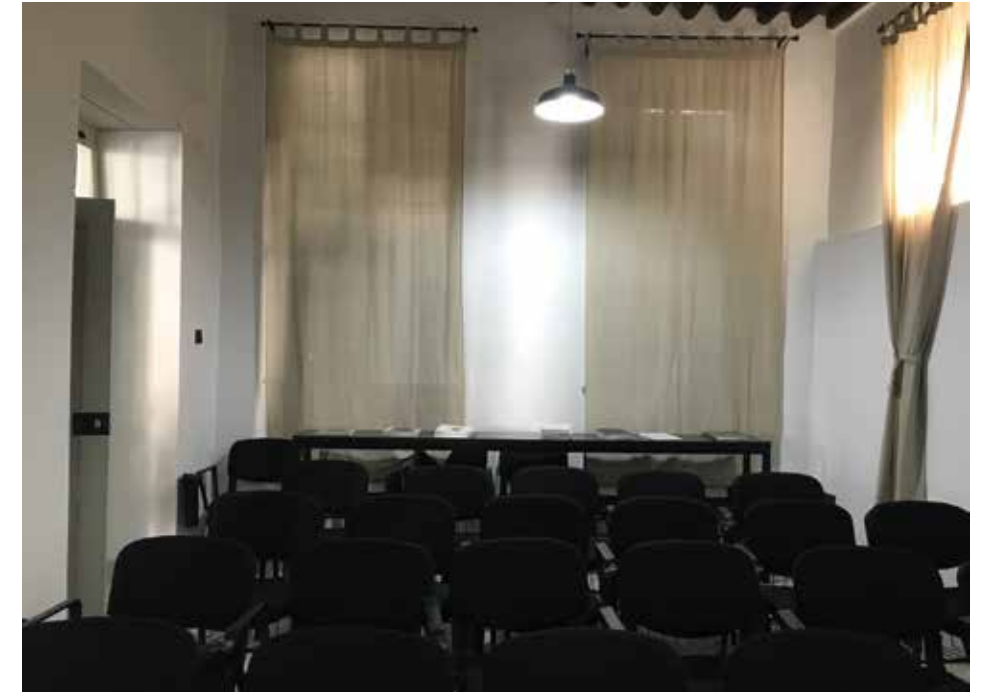
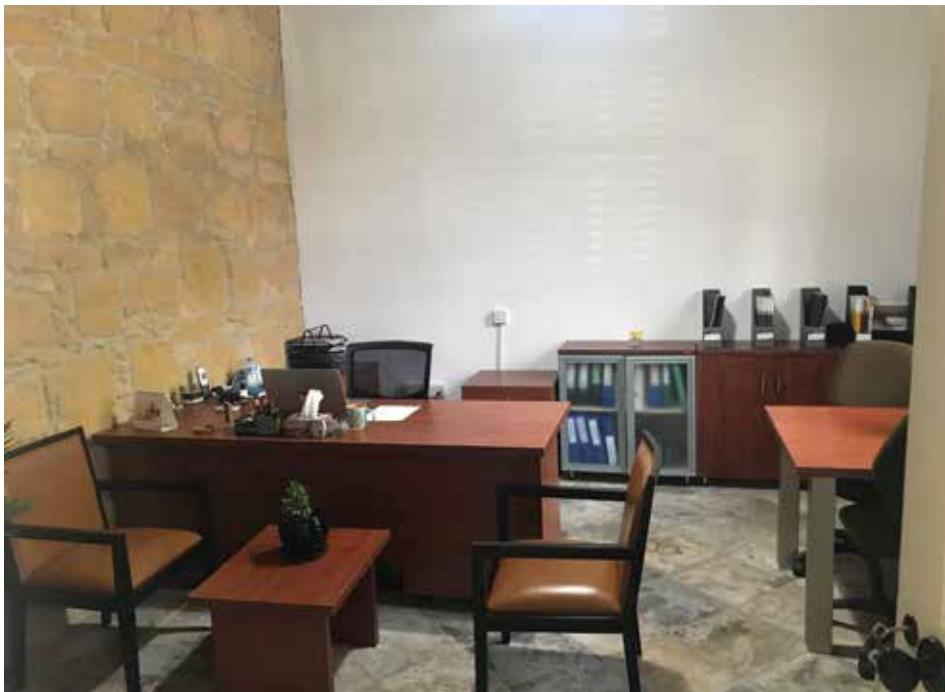
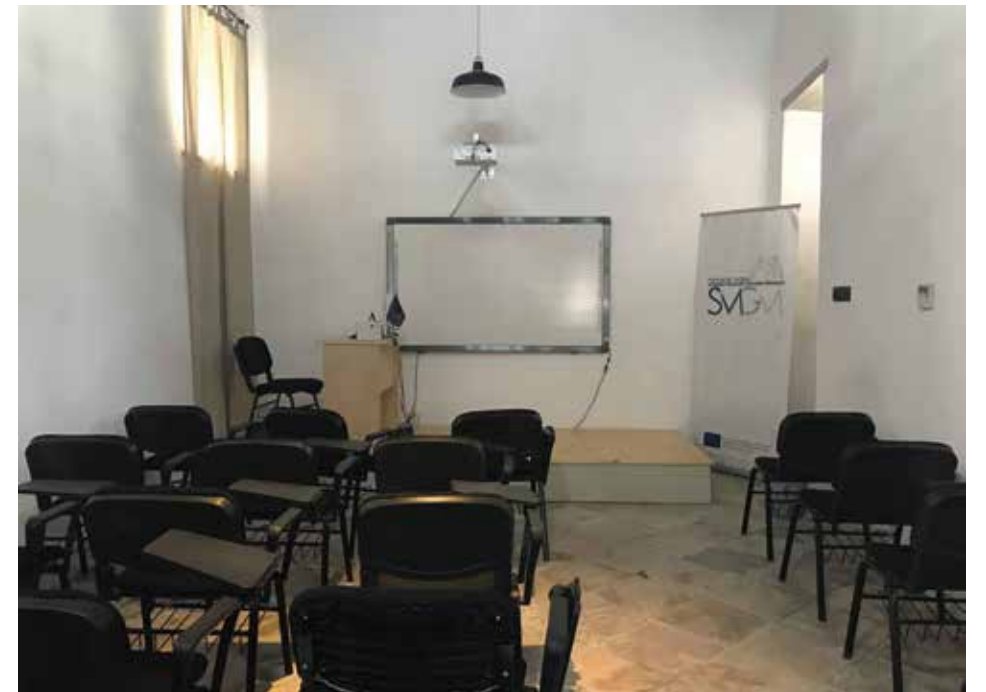
Figure 26a/b: Post-restoration condition and new use of the ground floor spaces: Entrance hall and CPDC office (Menteş, 2017)

Figure 26c/d: Post-restoration condition and new use of the ground floor spaces: CPDC seminar/training room

ground floor, the two rooms located to the right and left of the entrance hall (sofa) (Figure 25a, Room 1 and Room 2) were opened as the CPDC (Continuing Professional Development Center) seminar room and coordination office (Figure 25a). The rear courtyard room (Figure 25a, Room 3) continued to function as a kitchen, while the former toilet annex was renovated and converted into female, male and disabled facilities.

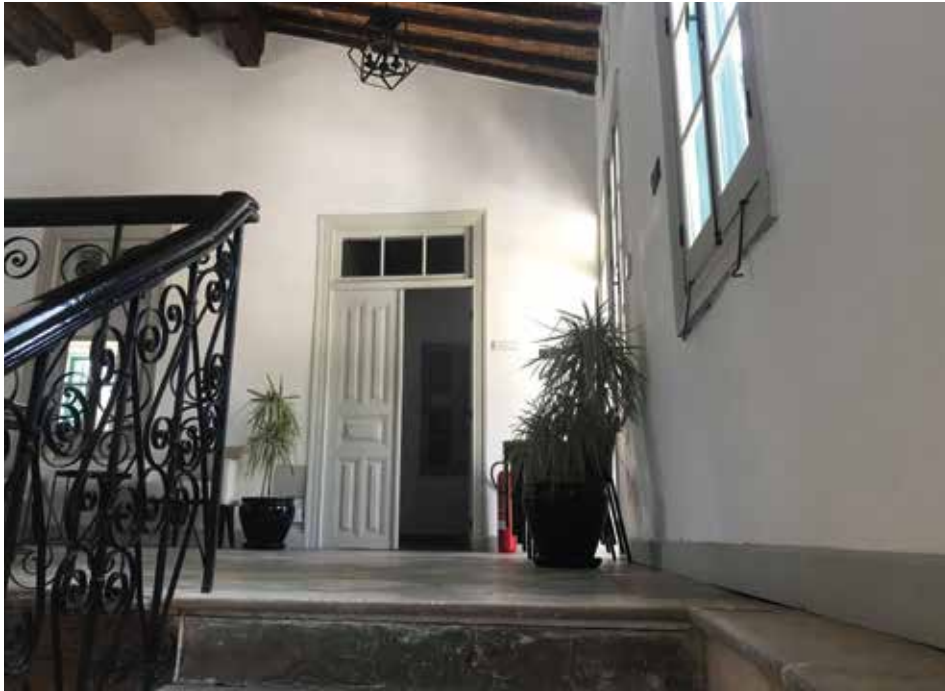
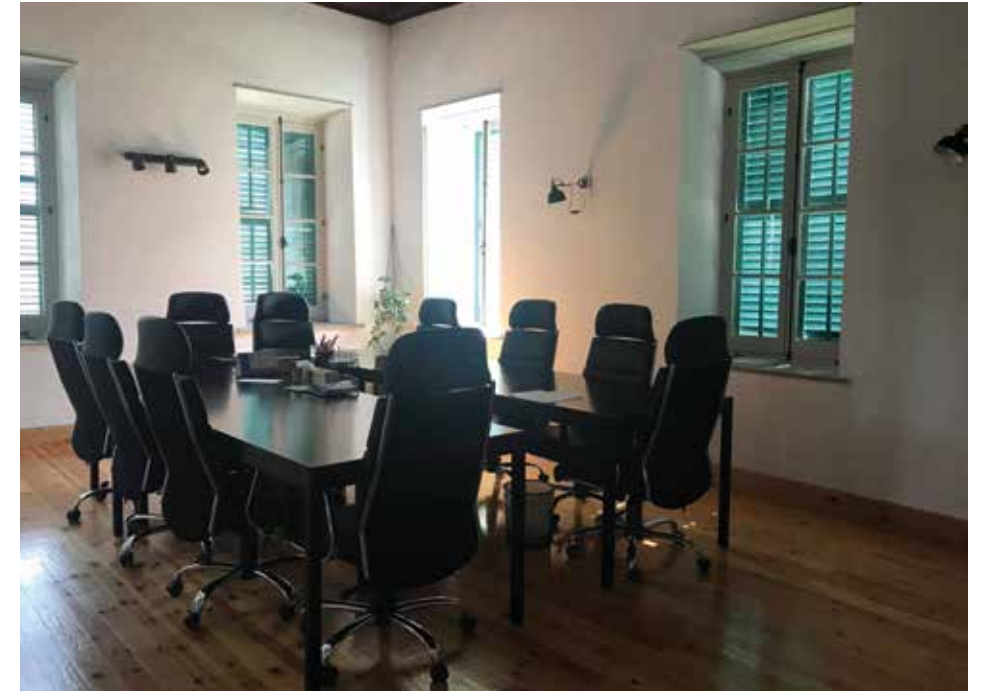
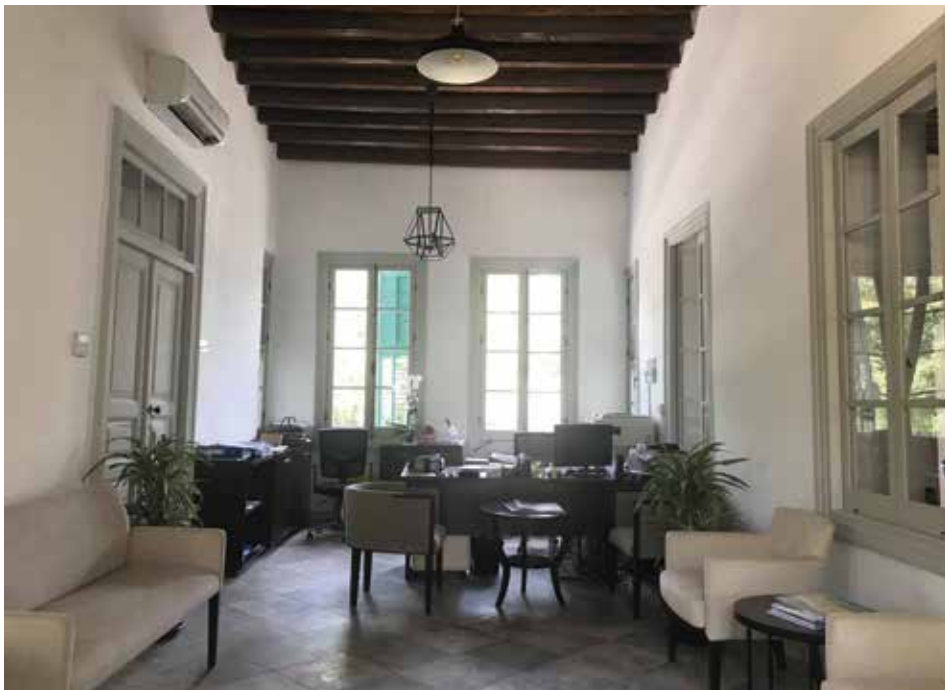
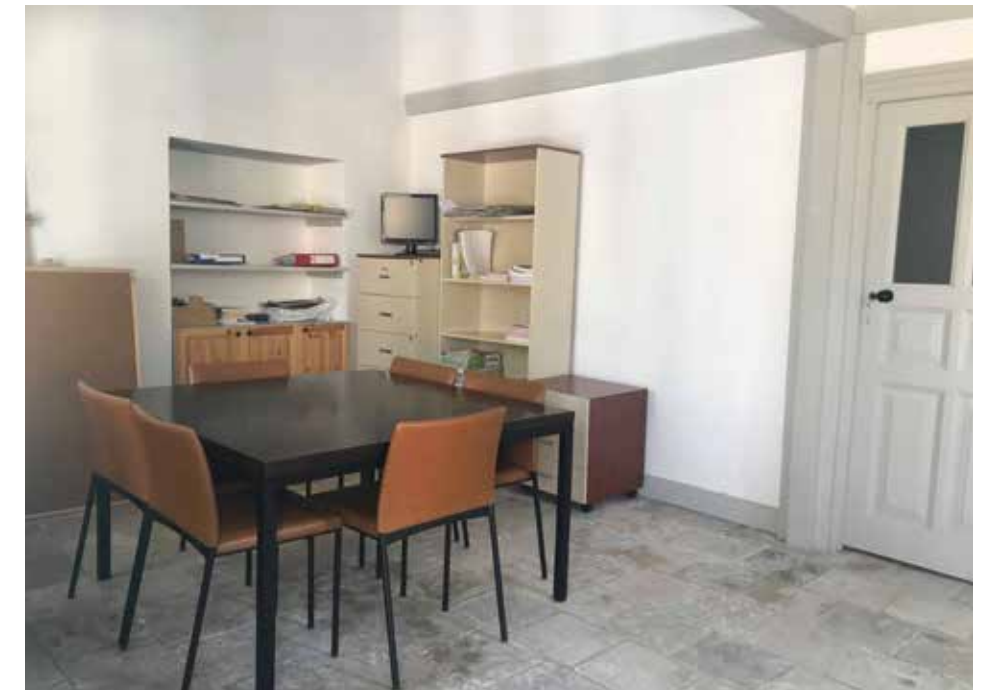
Figure 27 a/b: Post-restoration condition and new use of the first floor spaces: Secretary and reception (Menteş, 2017).

Figure 27c/d: Post-restoration condition and new use of the first floor spaces: Meeting rooms (Menteş, 2017).

The upper floor was designed for more private functions. The upper-floor hall (sofa) was used as the administrative secretary and waiting area (Figure 25b). The four rooms on this floor were adapted into a president's office (Figure 25b, Room 4), board meeting room (Figure 25b, Room 5), committee meeting room (Figure 25b, Room 6), and archive room (Figure 25b, Room 7).

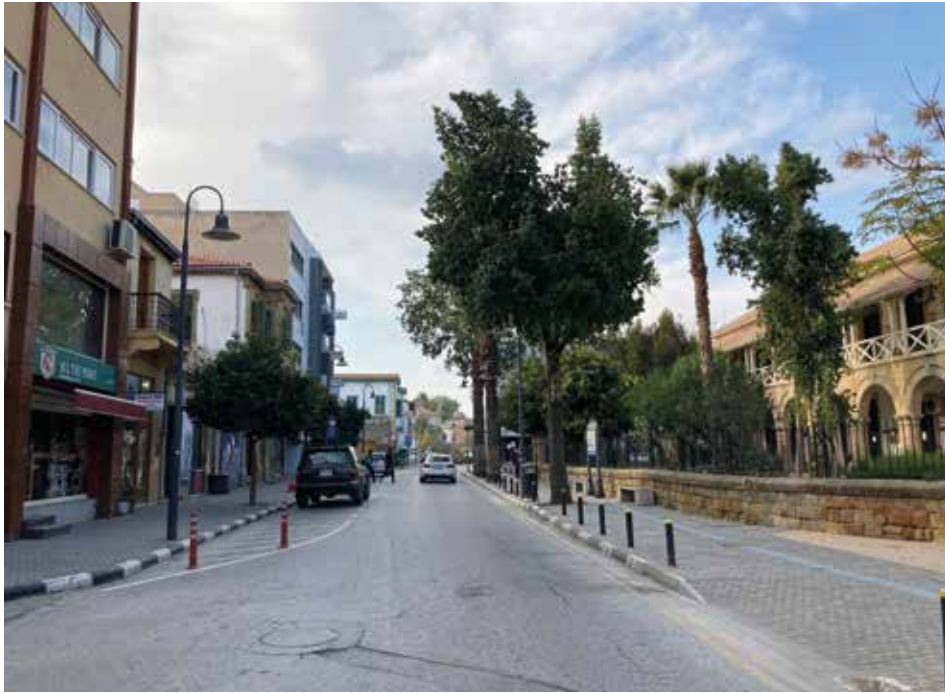
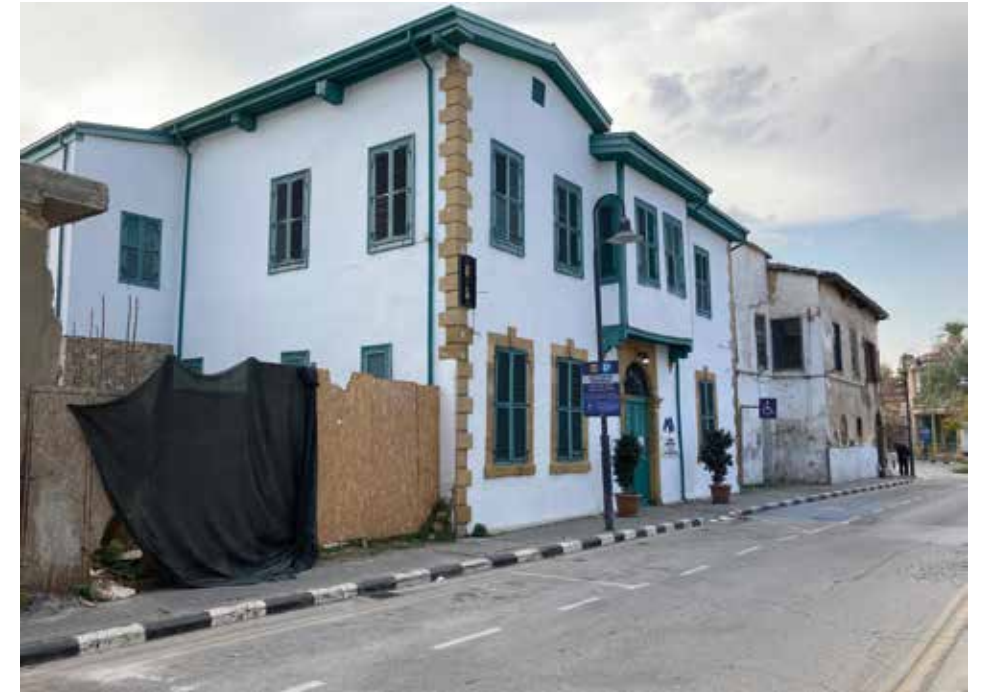
*Figure 28c: Front façade of the mansion post-restoration (Mimarca, 2018)*

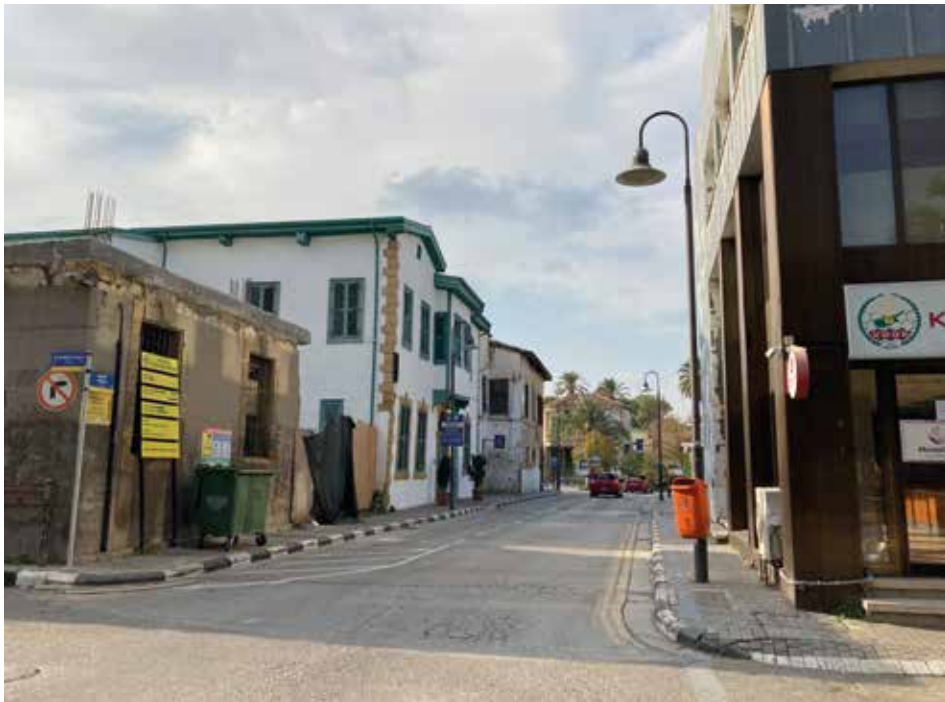
*Figure 28a/b: The view of the mansion post-restoration from the Nuri Efendi Street (Mimarca, 2018)*

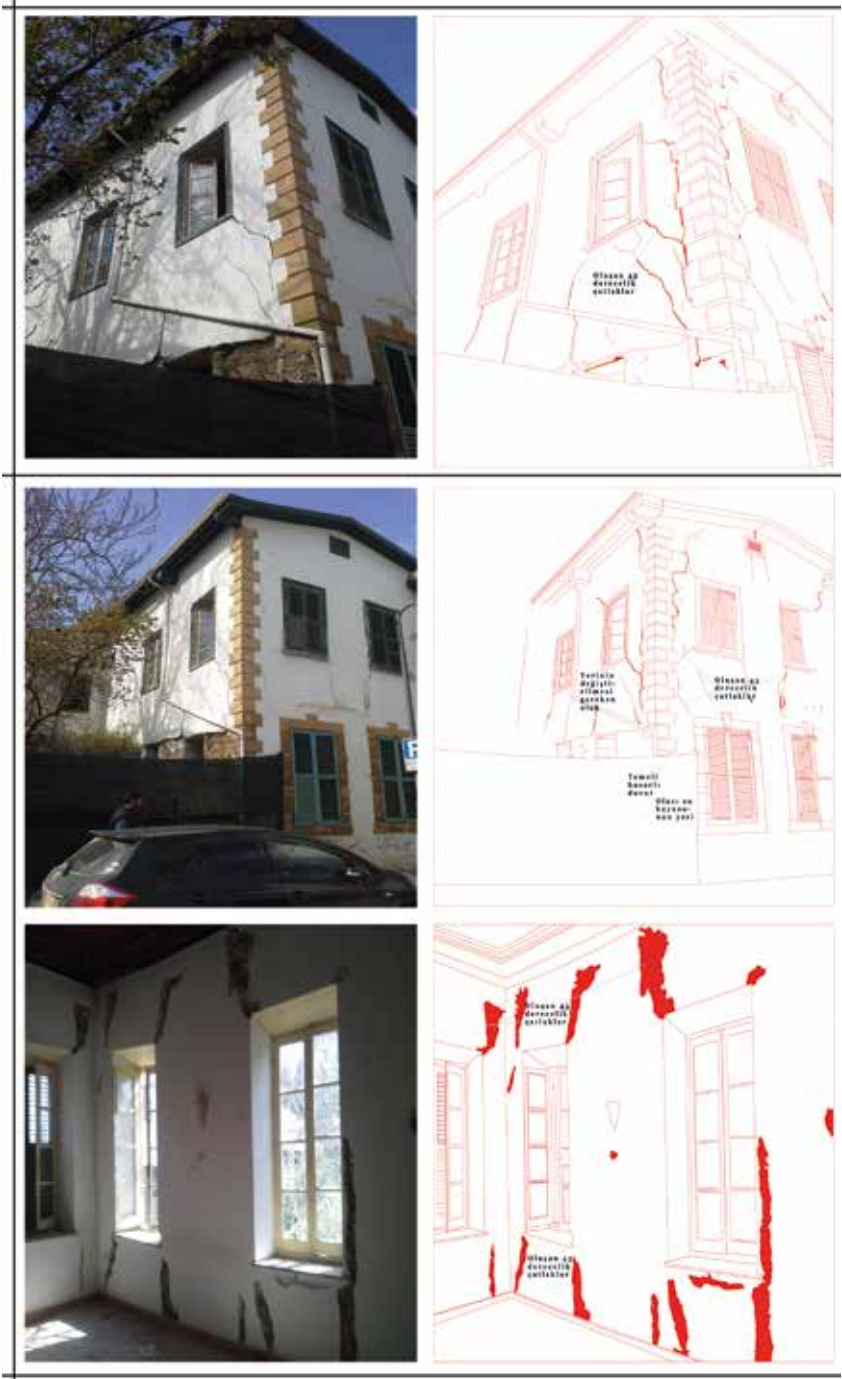
Appendix 2: Comparative damage assessment conducted in April and July 2015 by the civil engineer(Taneri, 2015)
